### RESEARCH MEMORANDUM

FACTORS THAT AFFECT OPERATIONAL RELIABILITY

OF TURBOJET ENGINES

By Lewis Laboratory Staff

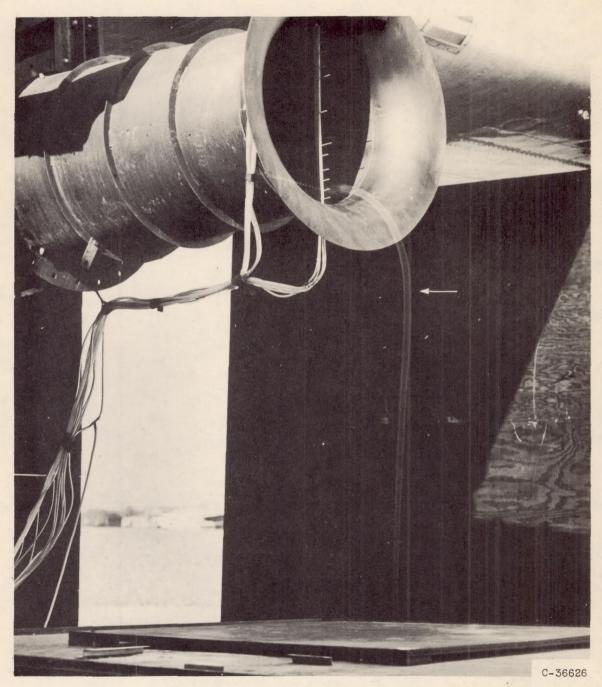
Figure 1. - Vortex formation between air inlet of gas-turbine engine and adjacent plane surface.

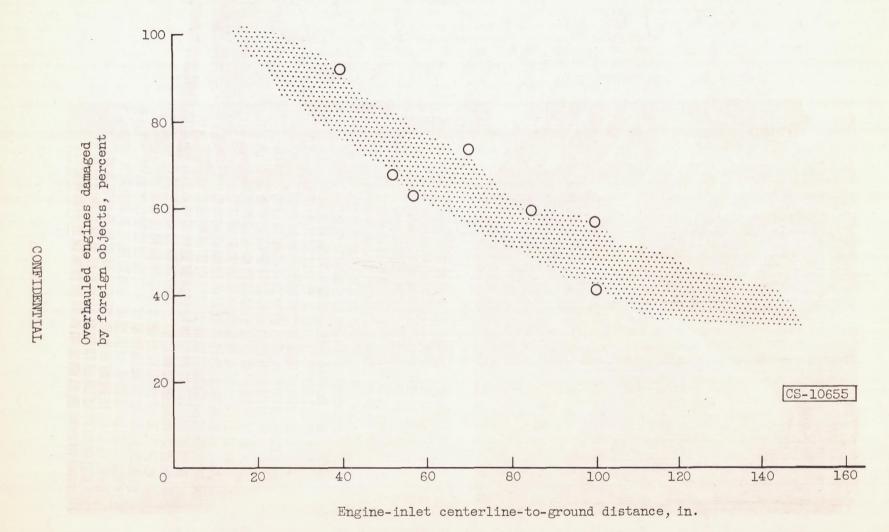
Figure 2. - Variations in damage to engines with engine-inlet height plotted for several representative Air Force aircraft.

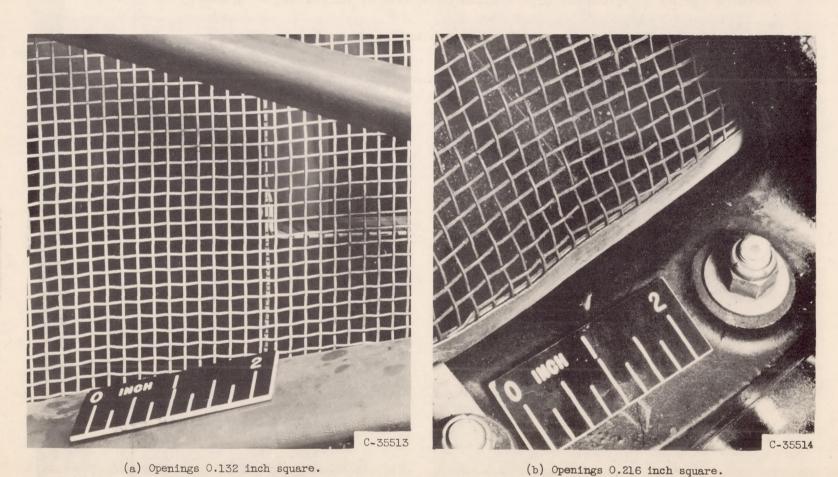
Figure 3. - Fixed air-inlet screens on centrifugal engines.

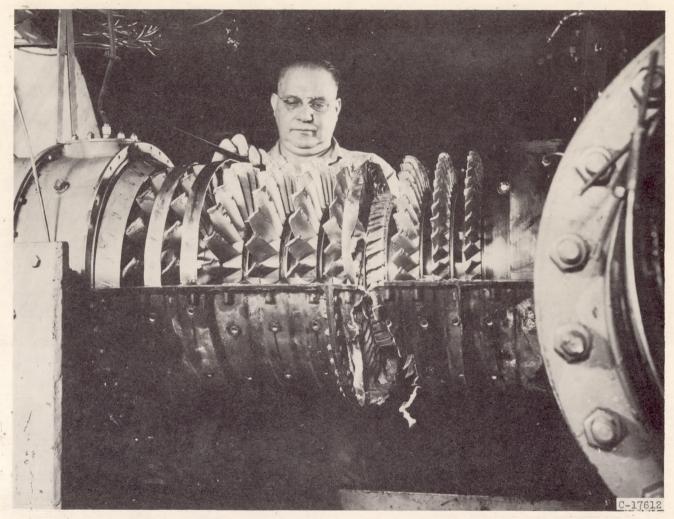
Figure 1. - Typical axial-flow-compressor failure resulting from fatigue of one first-stage blade.

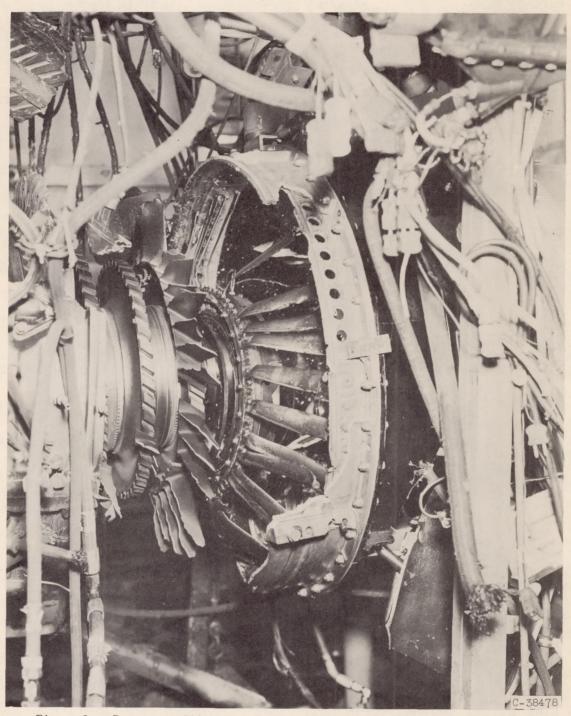
Figure 2. - Damage resulting from fatigue of blade root in second rotor stage.

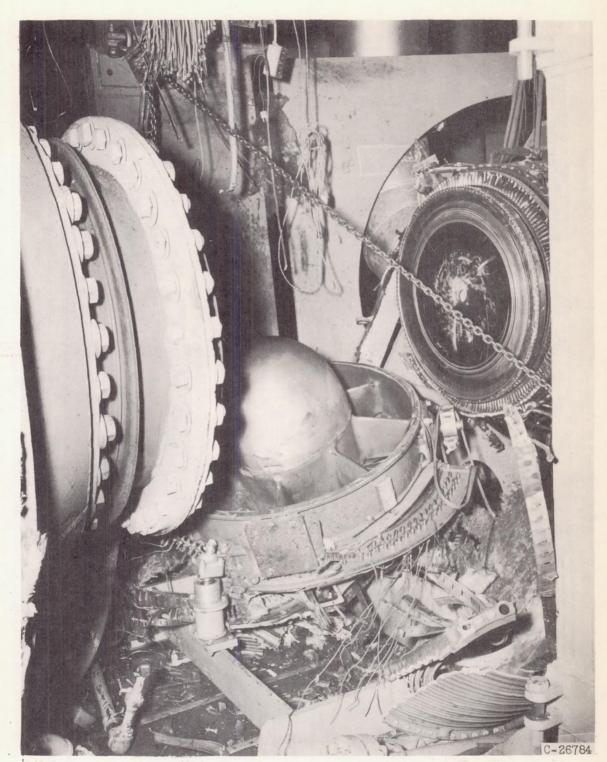
Figure 3. - Axial-flow-compressor failure.

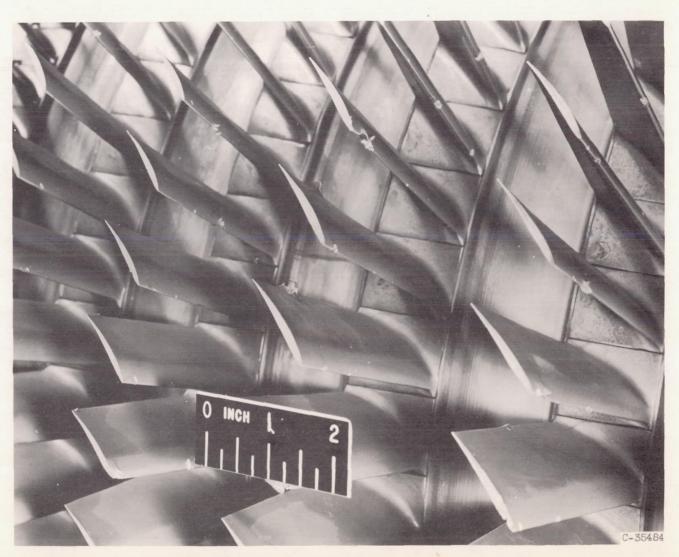
Figure 5. - Damage resulting from foreign object entering inlet.

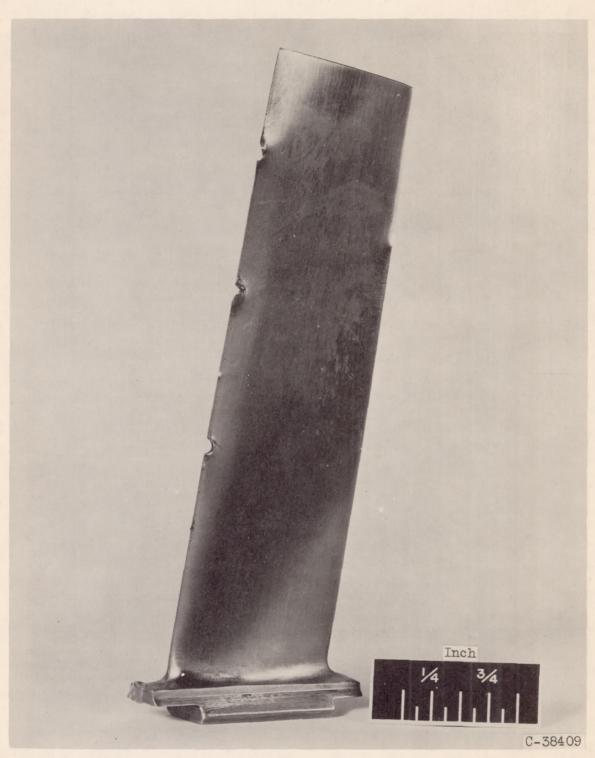
Figure 6. - Gouges in compressor blade caused by foreign object.

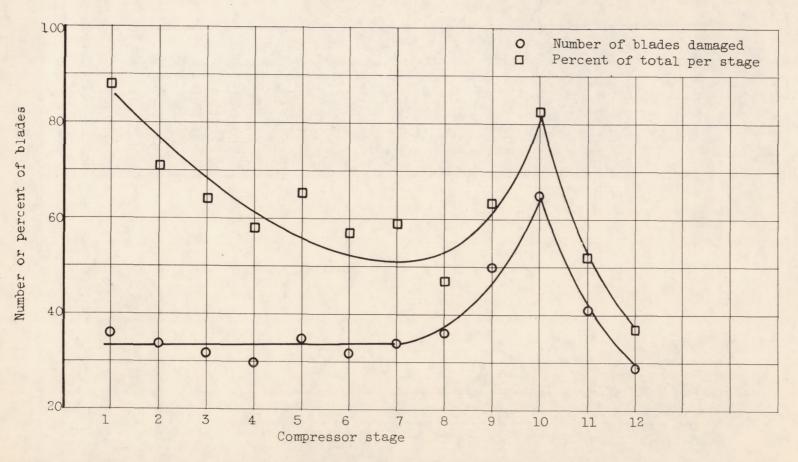
Figure 8. - Number of blades damaged by foreign object in typical axial-flow compressor.

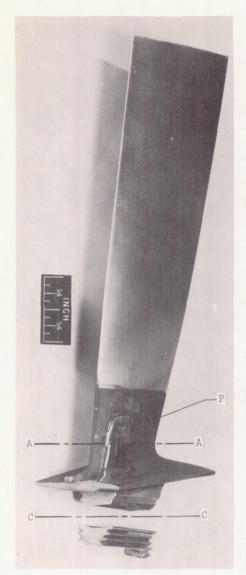
(a) Failed blade.

Figure 9. - Initiation points of fatigue in typical-compressor blade.

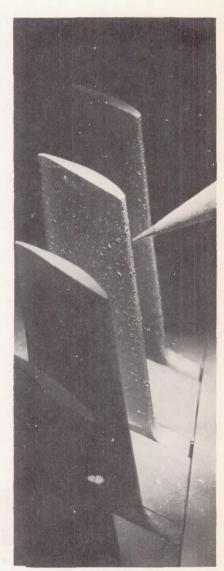
(d) Foreign-object damage.

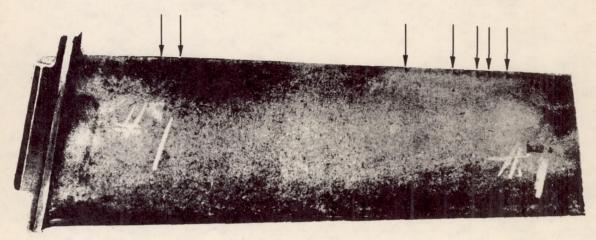
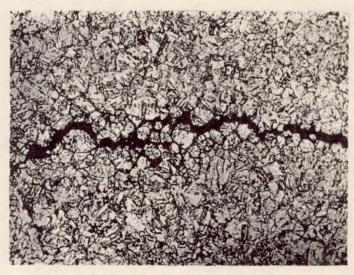
Stress-corrosion cracks

(a) Location of cracks.

(b) Photomicrograph of crack.

Figure 12. - Typical blade cracked by stress corrosion.

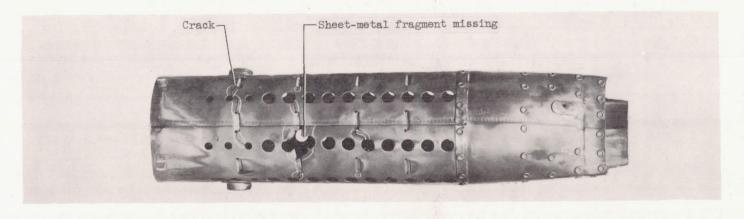
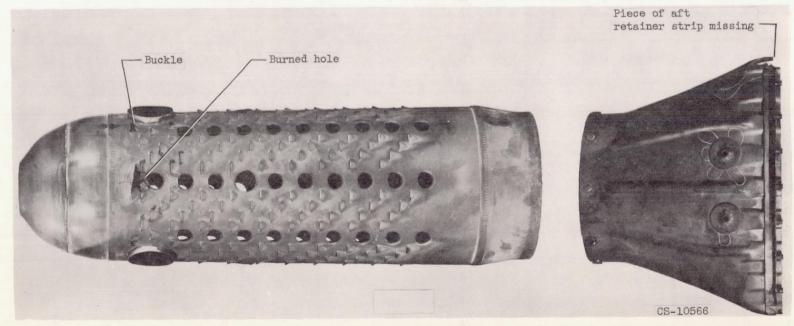
Figure 4. - Typical failures in turbojet liners.

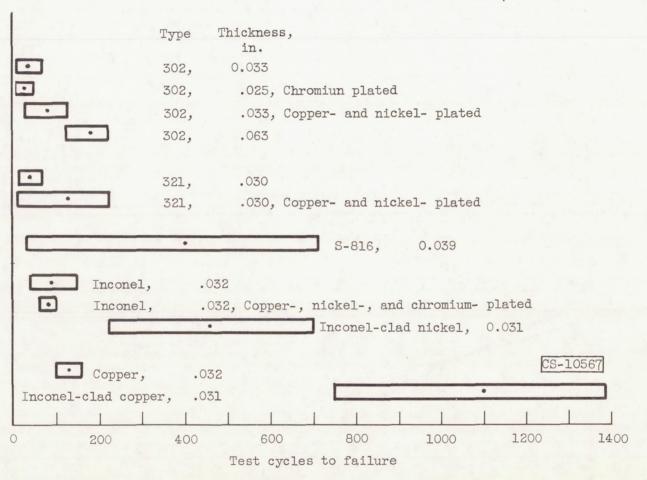
Figure 8. - Fracture due to repeated flame impingement. (Dot indicates average number of cycles for specimens of each material.)

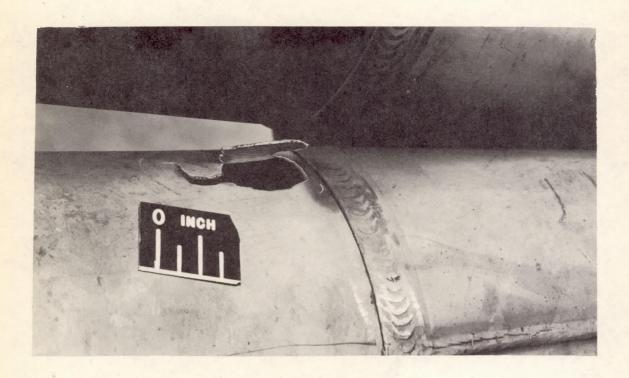
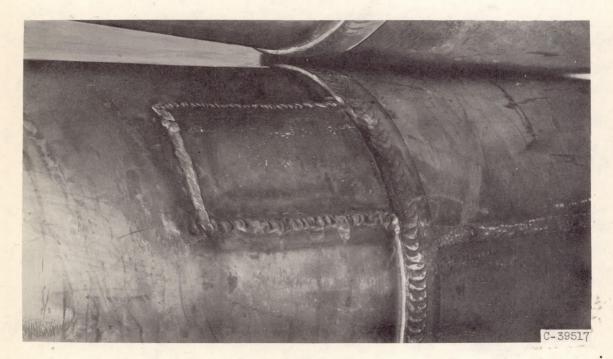
Figure 9. - Failure and patch in outer combustion chamber.

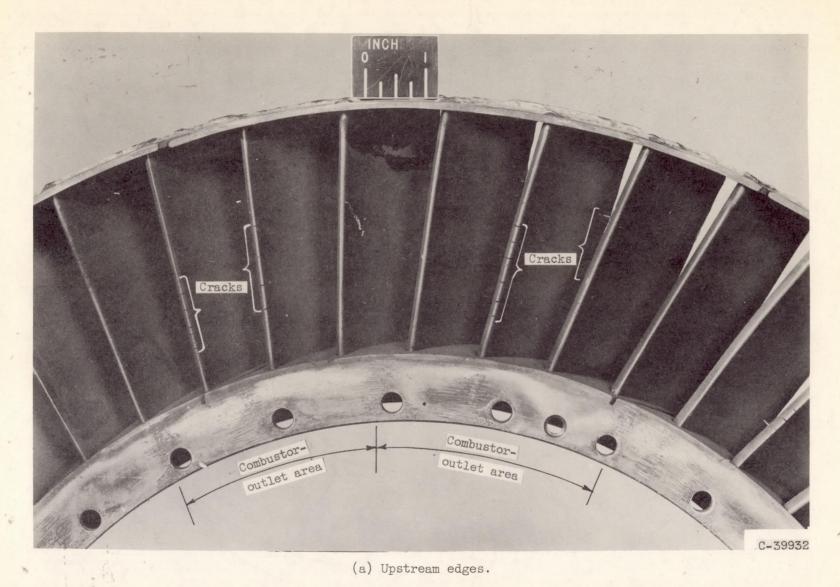
Figure 3. - Nozzle diaphragm showing cracks on edges of vanes (ref. 9).

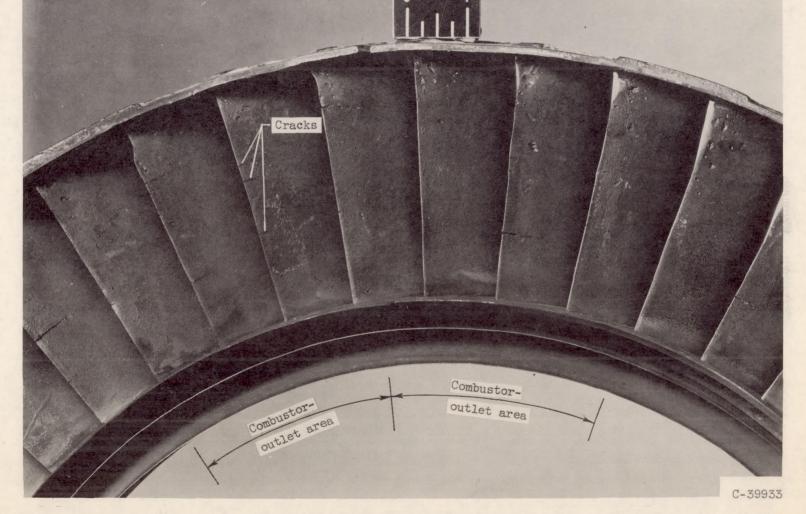
(b) Downstream edges.

Figure 3. - Concluded. Nozzle diaphragm showing cracks on edges of vanes (ref. 9).

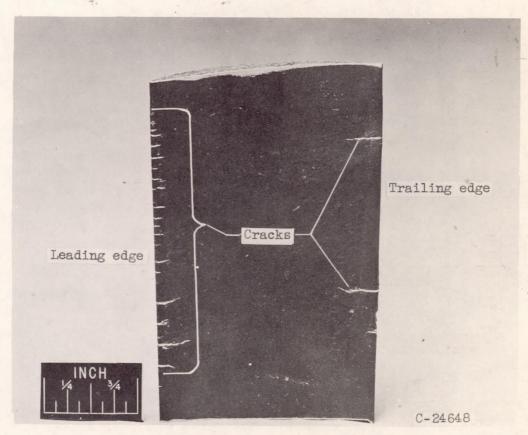
Figure 4. - Typical cracks in nozzle-diaphragm vane after 319 cycles (ref. 9).

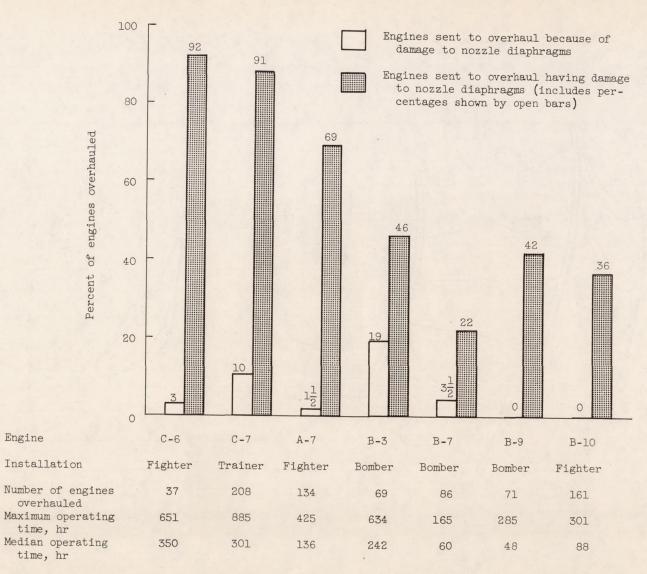
Figure 5. - Damage to nozzle diaphragm reported at overhaul depots. (Data obtained from DIR's, August, September, October, 1953.)

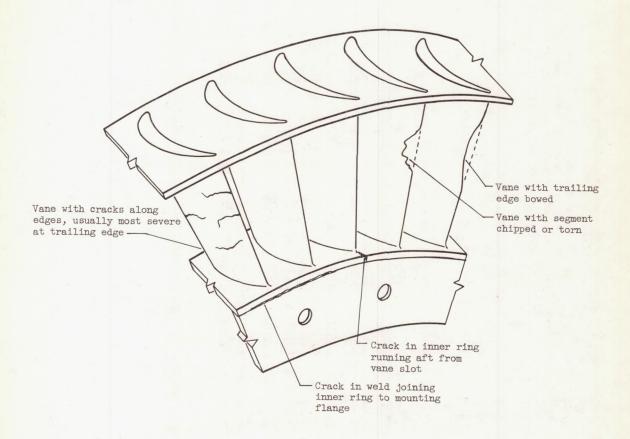
Figure 6. - Types of damage most common to nozzle diaphragms.

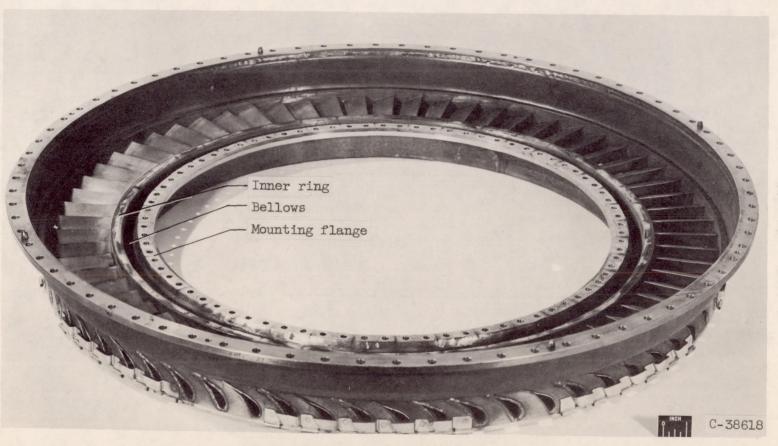
(a) From early engine.

Figure 14. - Nozzle diaphragm.

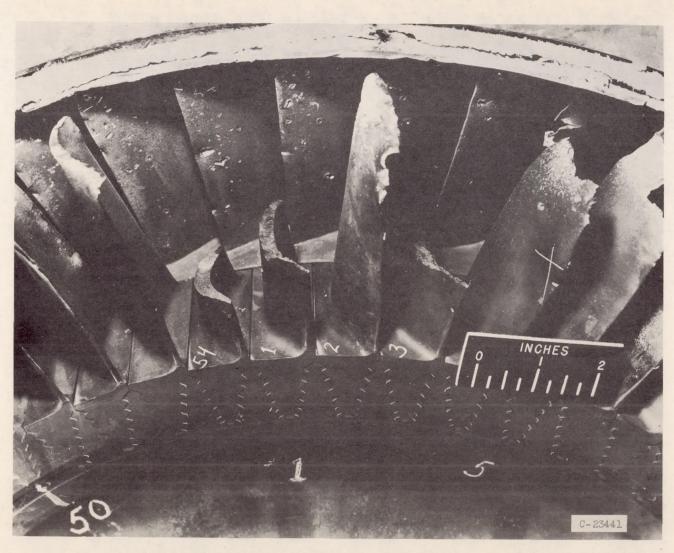
Figure 1. - Damage to single-stage turbine resulting from bucket failure (number 54).

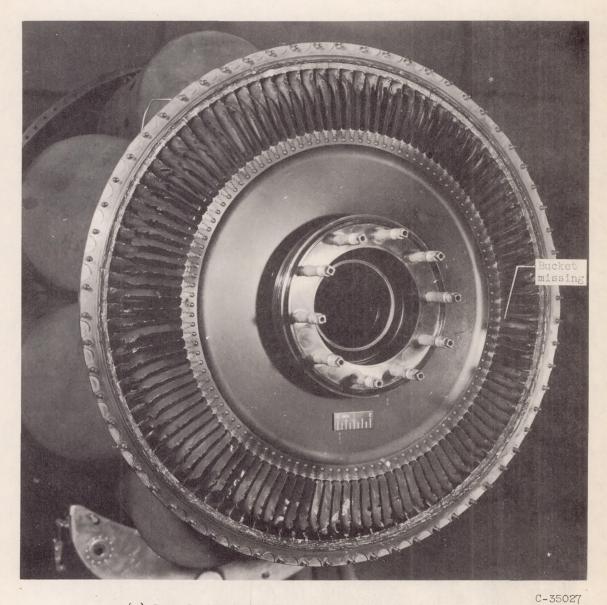
(a) Second stage of turbine; all bucket shrouds gone.

Figure 2. - Damage to three-stage turbine resulting from failure of second-stage bucket.

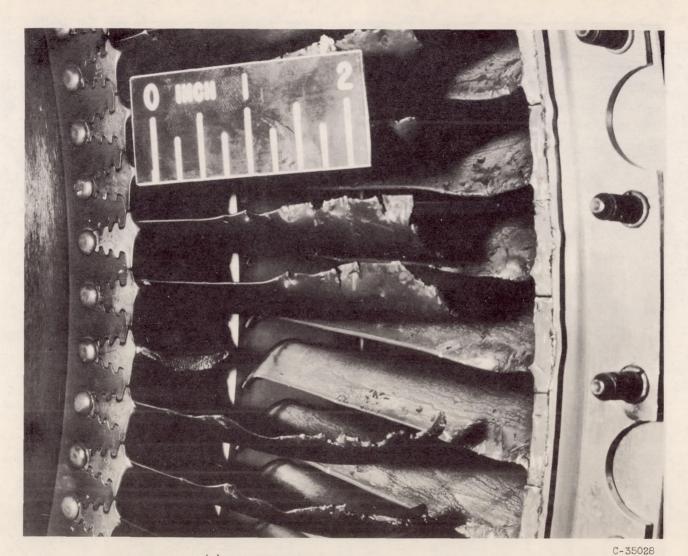
(b) Close-up of fractured second-stage bucket.

Figure 2. - Continued. Damage to three-stage turbine resulting from failure of second-stage bucket.

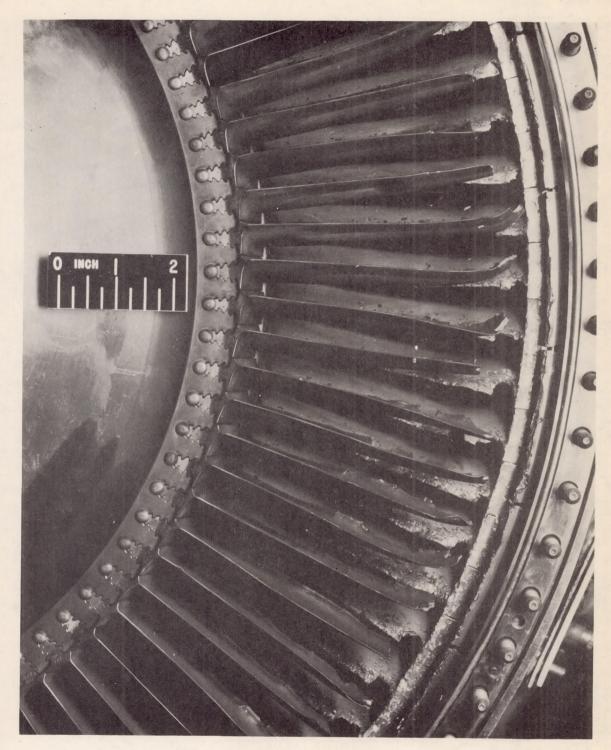
(c) Third stage of turbine; all bucket shrouds gone.

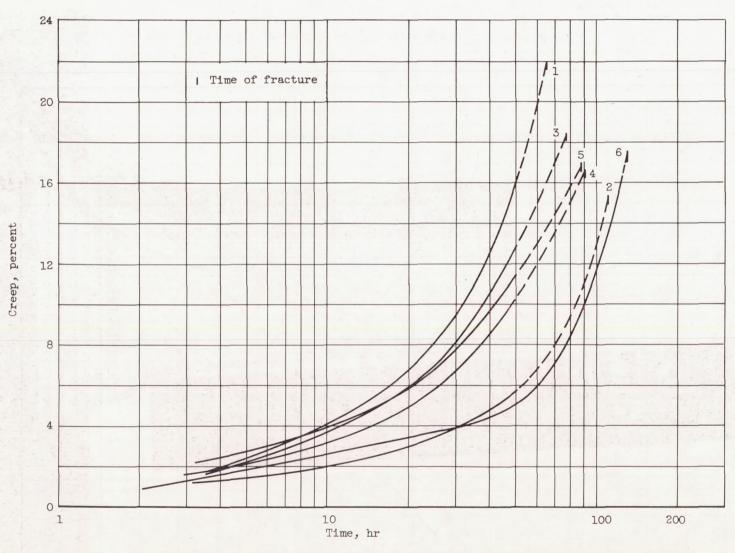
Figure 11. - Necked bucket.

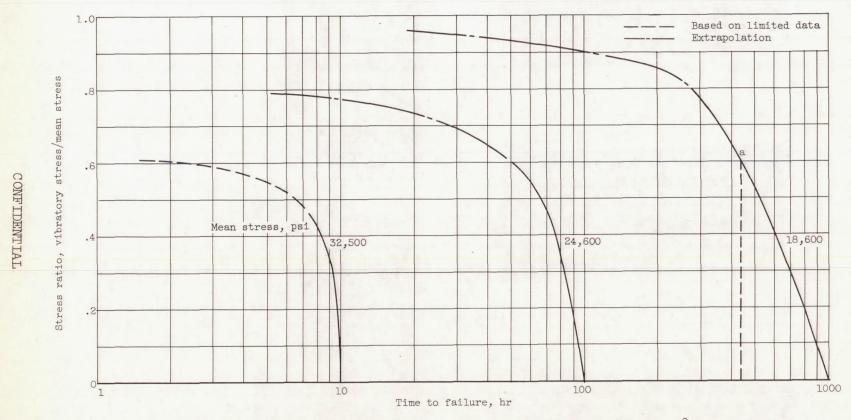
Figure 17. - Typical fatigue failures.

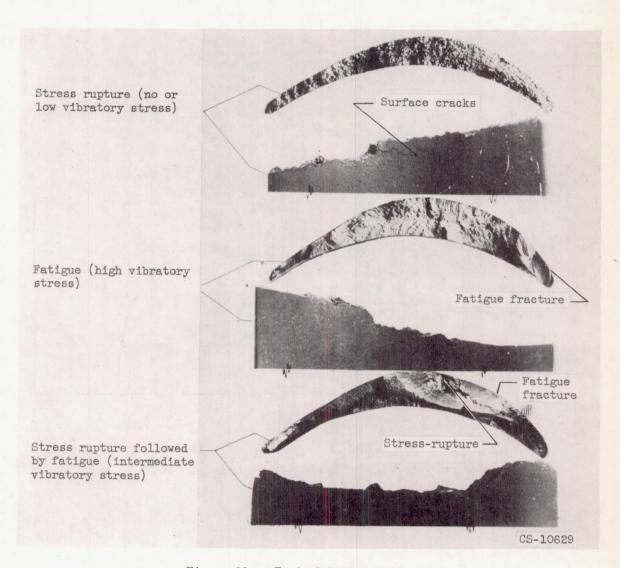
Figure 20. - Typical bucket failures.

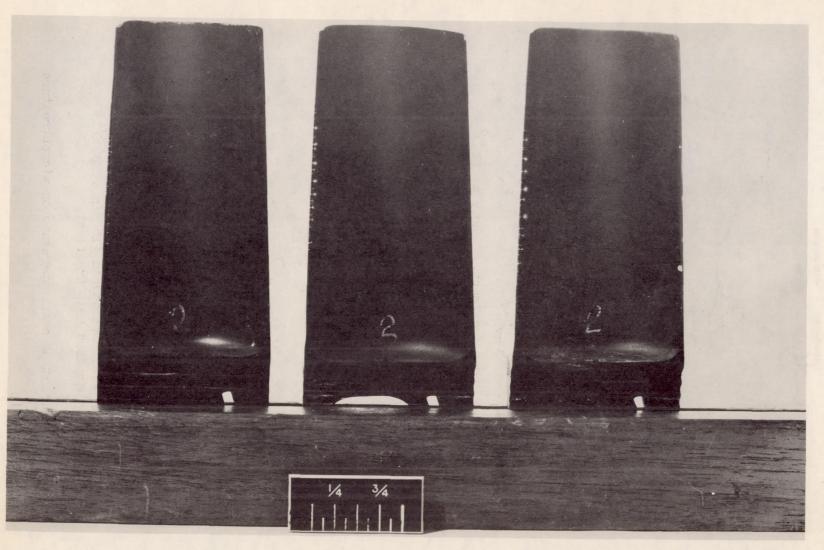
Figure 24. - Leading-edge cracking from repeated thermal gradients.

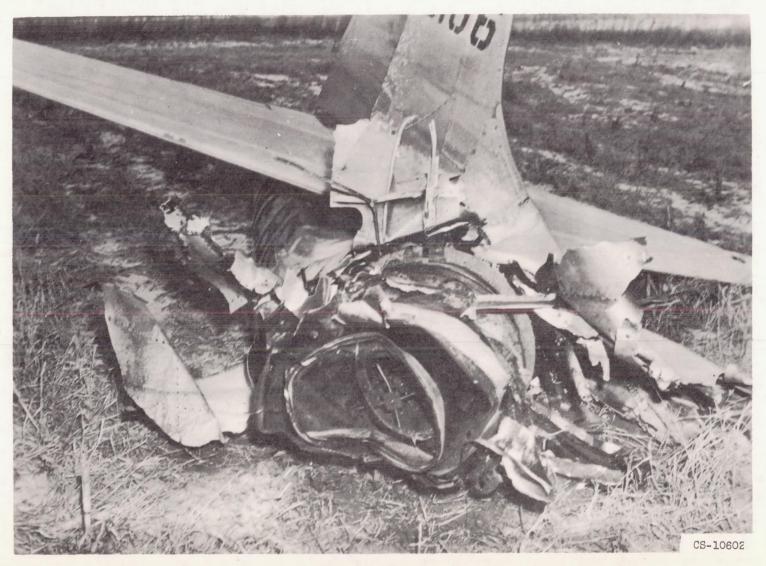
Figure 2. - Tail section of airplane that crashed as a result of turbine-disk failure.

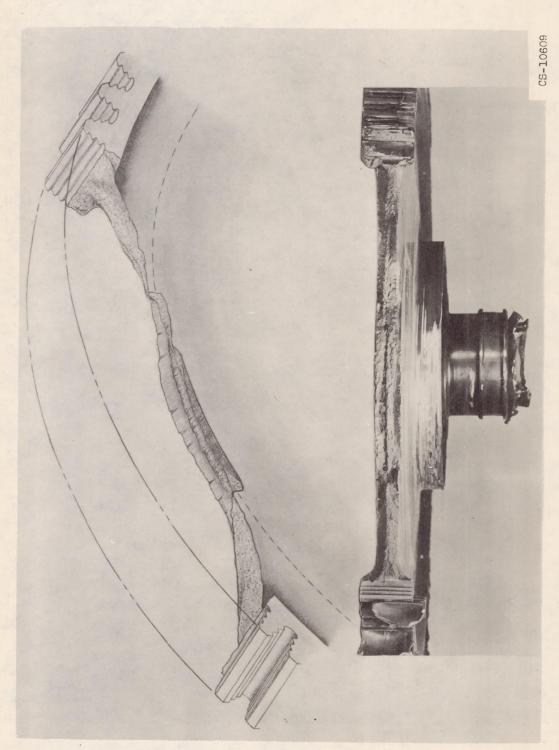
Figure 11. - Weld failure.

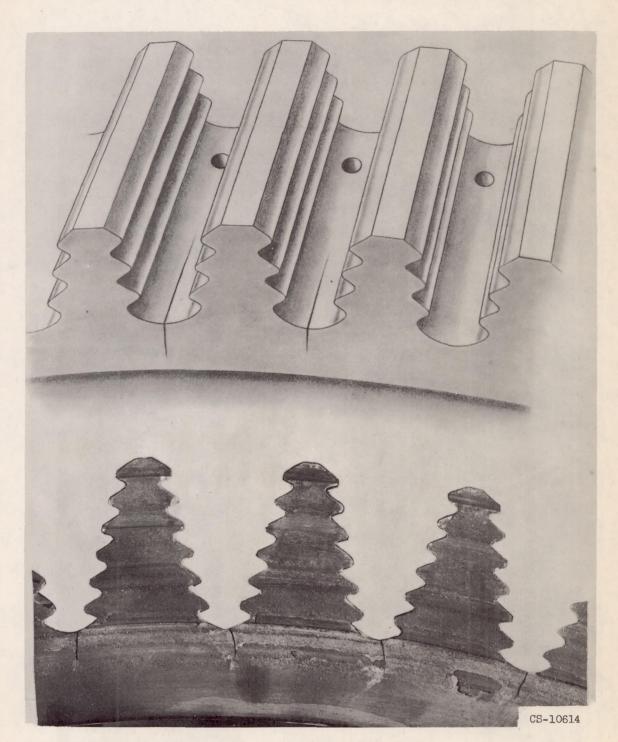
Figure 12. - Thermal-fatigue cracks.

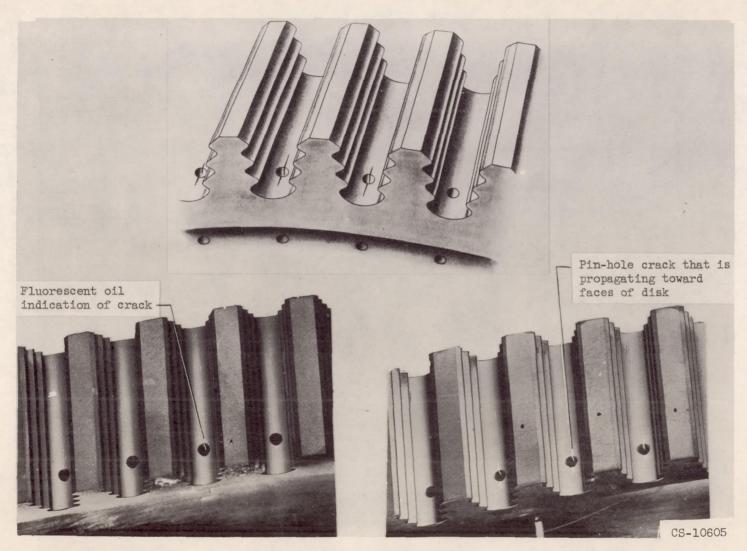
Figure 13. - Pin-hole cracks.

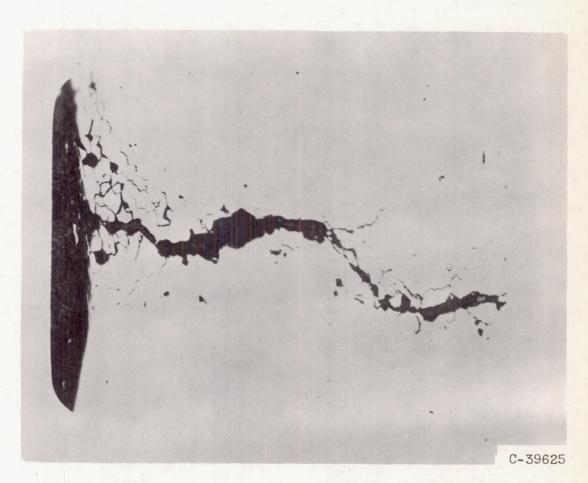
Figure 14. - Intergranular corrosion and crack at pin hole. Unetched; X100; obtained from reference 9.

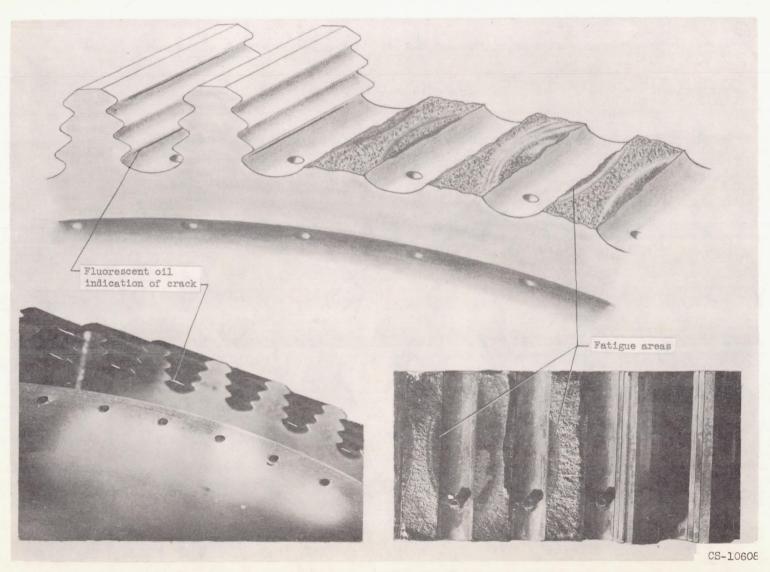
Figure 18. - Serration failure.

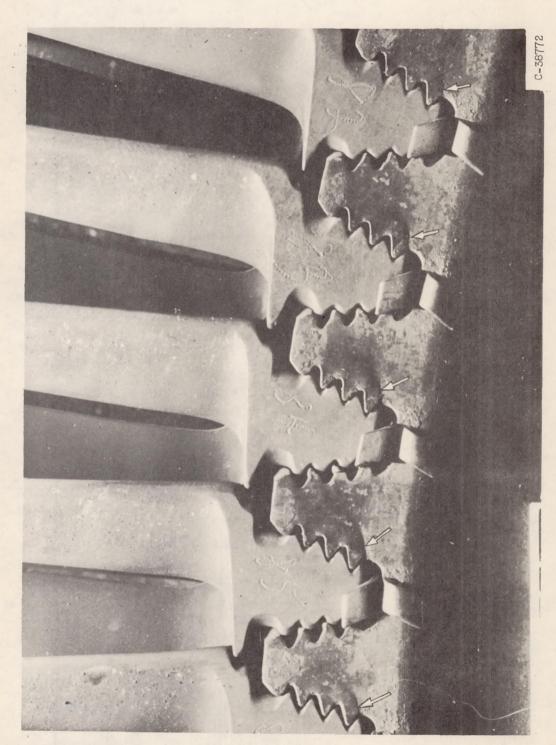
Figure 19. - Serration tensile failures resulting from nonuniform loading.

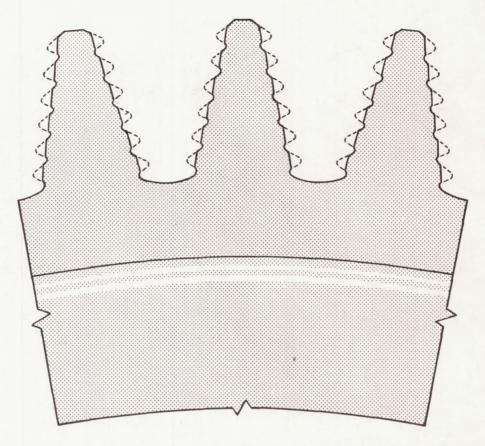
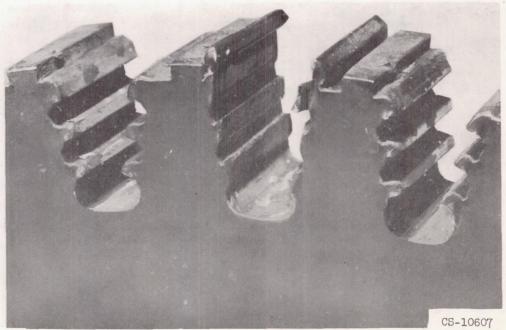
Figure 20. - Serration shear failure.

Figure 20 shows a spin-pit disk that has suffered a shear failure.

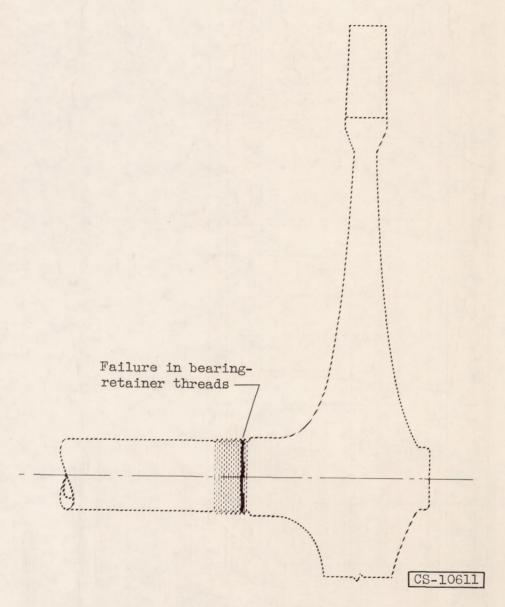
Figure 21. - Turbine-shaft failure.

A typical turbine-shaft failure is represented schematically in figure 21. Failure generally occurs at stress-concentration points such as those at the bearing-retainer threads. Since this region of the disk operates at relatively low stress, the failures are attributed to unusual operating conditions. Several possible causes are (1) torsional vibration of the shaft, (2) overheating of the shaft caused by faulty bearing operation, (3) failure of the cooling-air supply to the bearing, (4) sudden unbalance loads imposed by bucket failures and (5) gyroscopic loads.

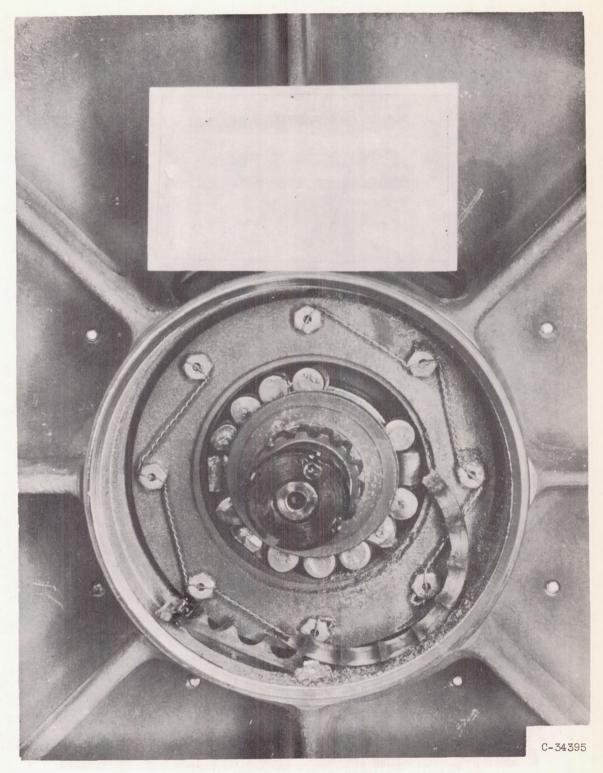
Figure 5. - Bearing failure resulting from oil interruption. Engine with jet lubrication of bearings. Photograph shows cage has failed completely. Failure occurred 17 minutes after the oil interruption. (From appendix B, ref. 1) Other photos of engine in figures 6 and 7.

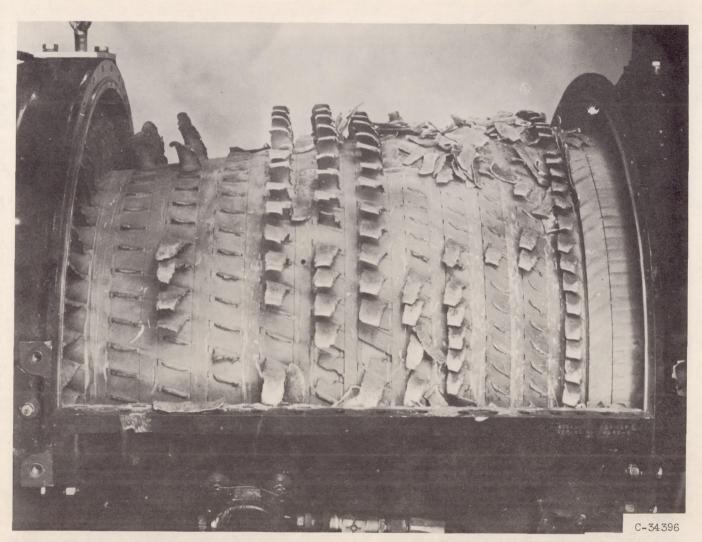
Figure 6. - Compressor damage resulting from bearing failure in oil interruption tests. Same engine as in figures 5 and 7. (From appendix B, ref. 1.)

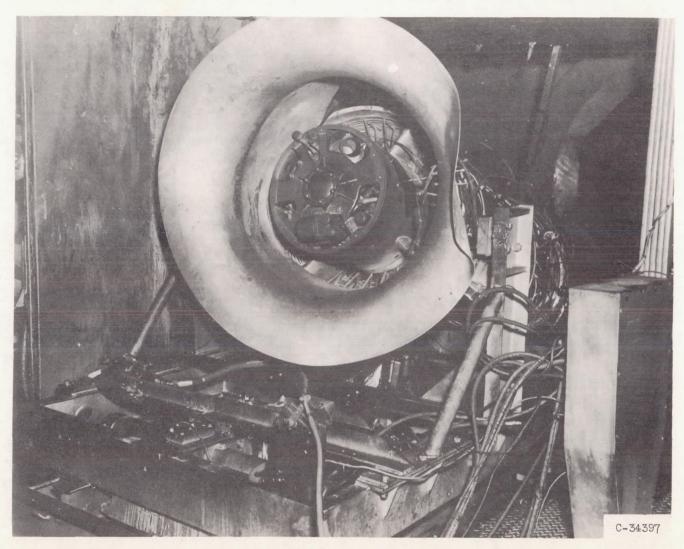
Figure 7. - Engine torn from test mount as result of engine stoppage by bearing failure in oil interruption tests. Same engine as for figures 5 and 6. (From appendix B, ref. 1.)

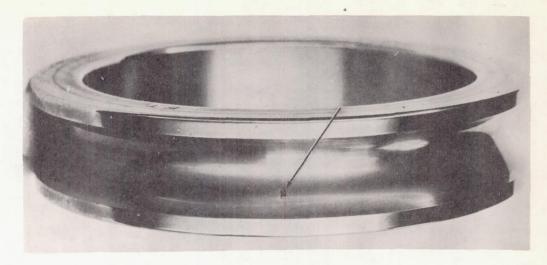
(a) Early stage of flaking on inner raceway of deep-groove ball bearing caused by fatigue.

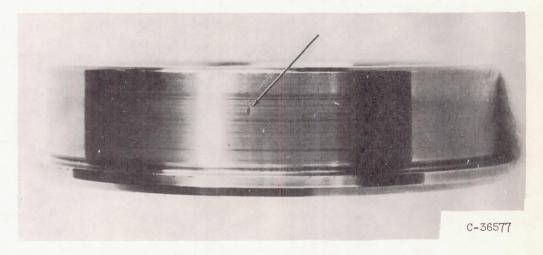
(c) Early stage of flaking on inner raceway of cylindrical roller bearing caused by fatigue.

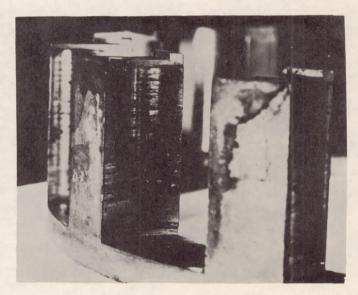
(b) Smearing on cage pockets.

Figure 12. - Typical cylindrical roller bearing failure caused by inadequate lubrication between rollers and cage pockets. (From ref. 15.)

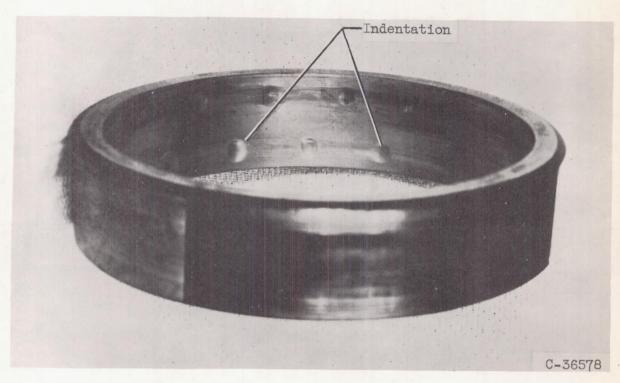
Figure 13. - False brinelling of the outer race of a double-row self-alining ball bearing caused by vibration without bearing rotation. (From ref. 15.)

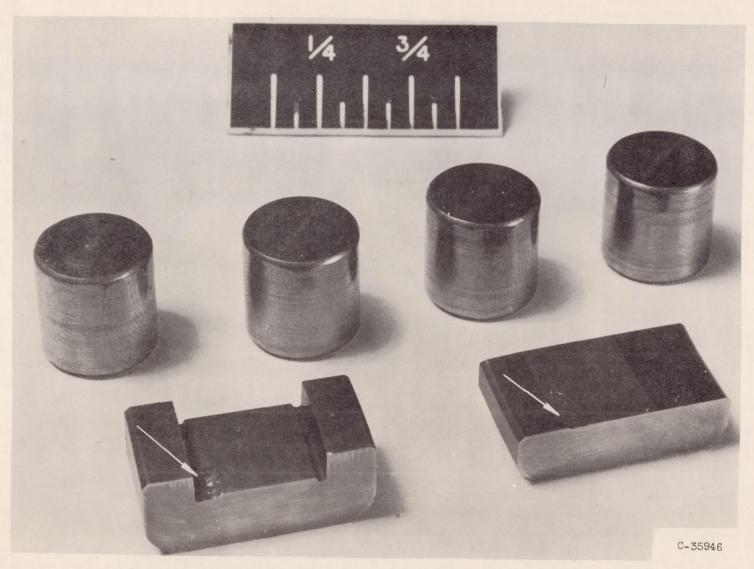
Figure 14. - Cylindrical roller bearing that failed because of misalined load.
